LIVE OAK ASSOCIATES, INC.

December 14, 2018

Subject: Amended Tree Survey and Report for 2550 Camino Tassajara property in the Town of Danville, California (LOA PN 2172-01)

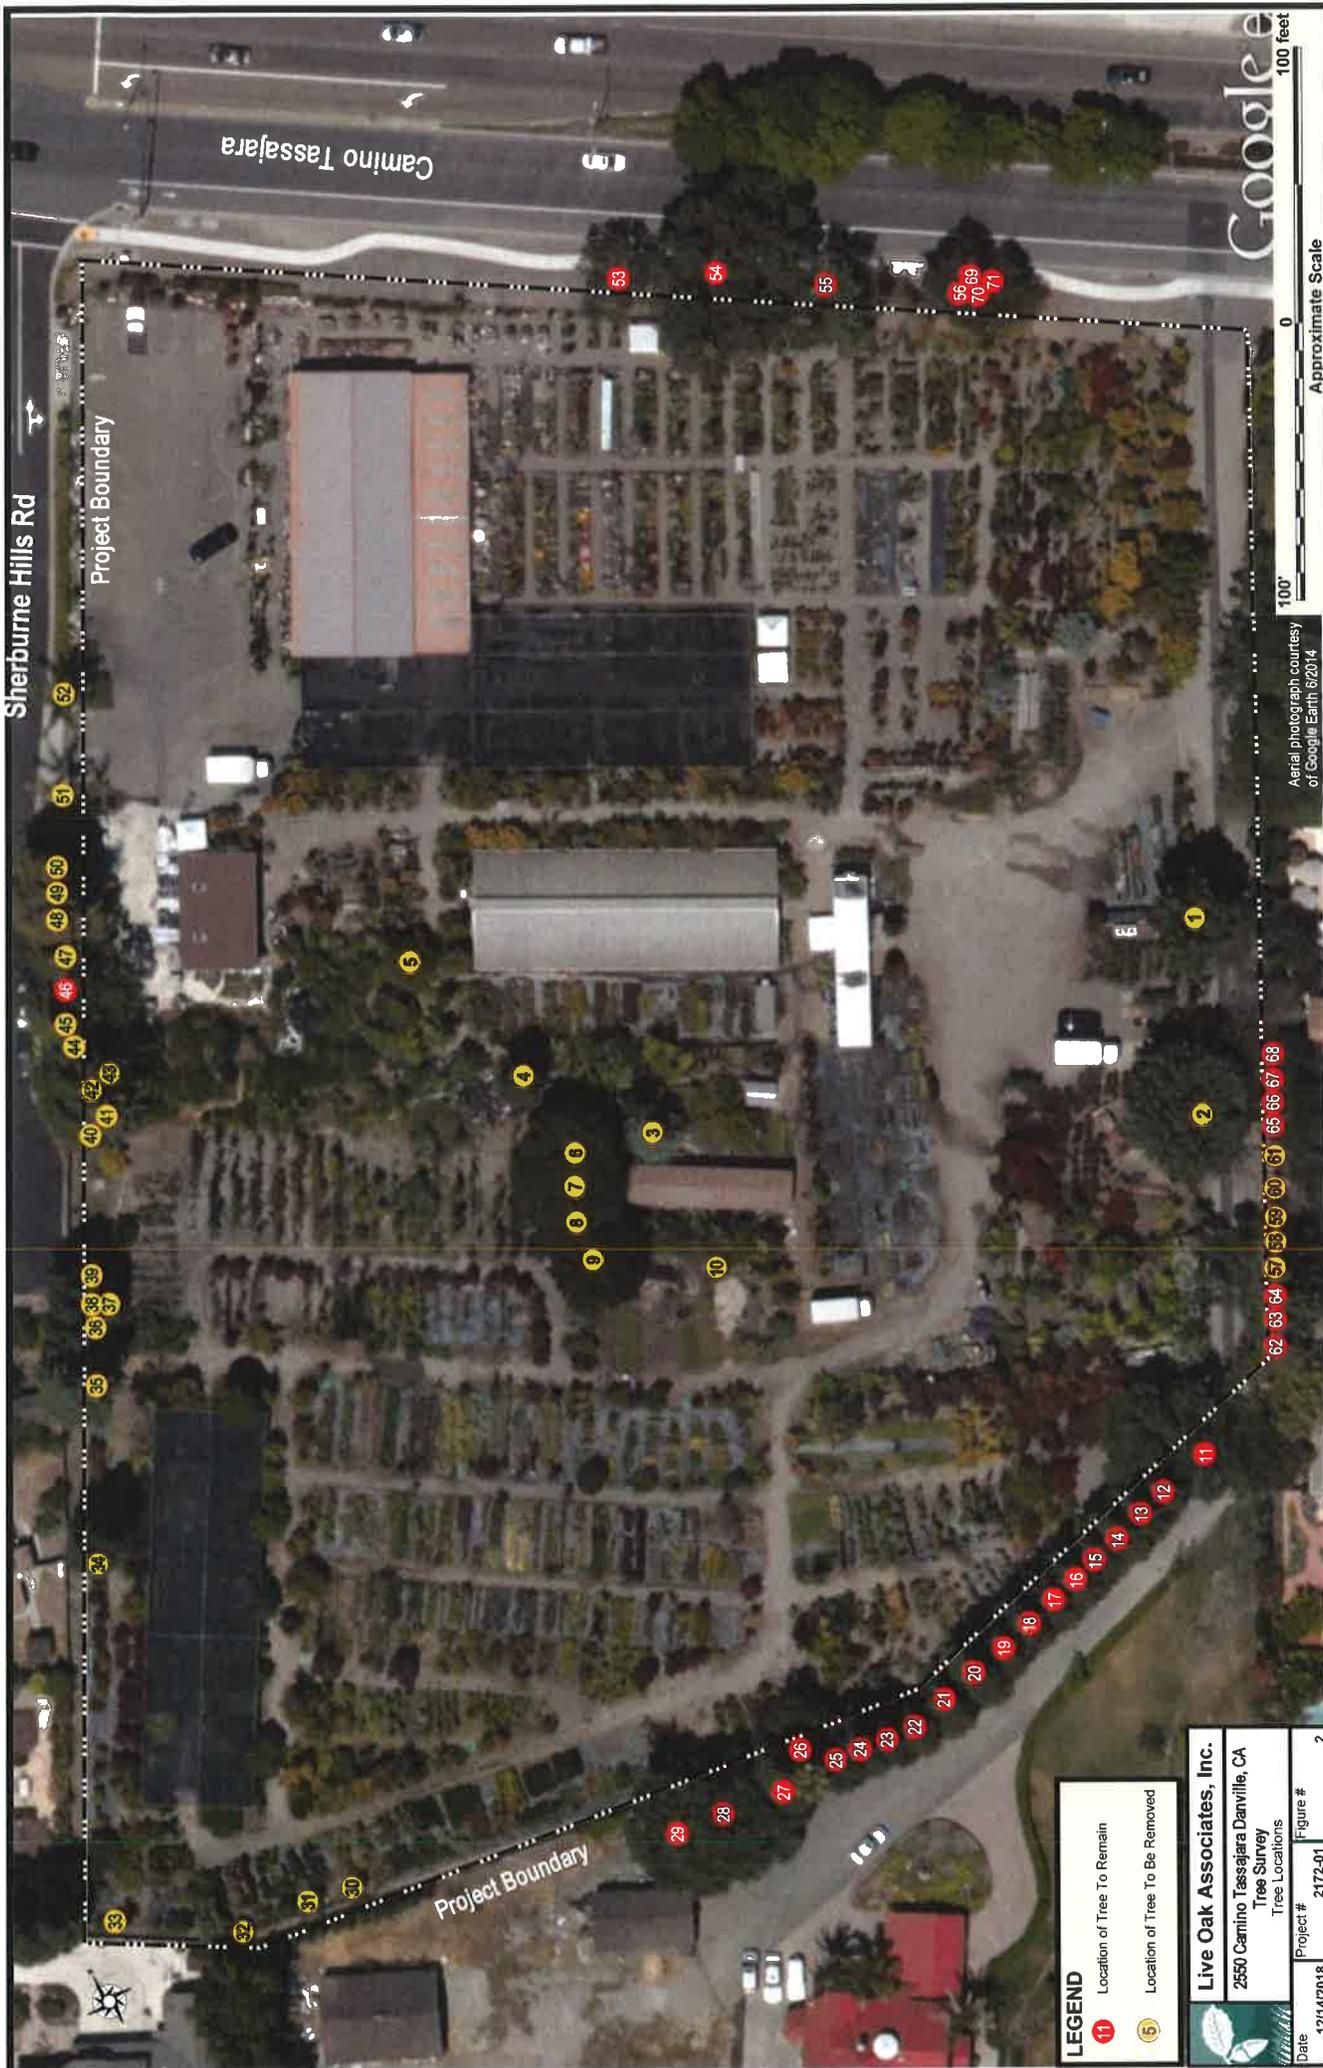
Date 12/14/2018 Project # 2172-01 Figure # 2

A total of 71 trees were documented during September 2017, July 2018 and November 2018 surveys. Approximate locations for all trees surveyed are shown on Figure 2 and a summary of information collected for each tree is provided below in Table 1.

Based on a conceptual site plan provided by Trumark Homes and dated November 27, 2018, it is projected that 37 trees will be removed for project development. Trees projected for removal are identified under the Retain/Remove column on Table 1 and are indicated in yellow on tree location map Figure 2.

Trees projected for removal include seven Protected Trees. These include three valley oaks (trees 1, 2 and 57) and four coast live oaks (trees 58, 59, 60, 61).

The list of trees to be removed in this report is preliminary. Once final site and grading plans are in place, these plans should be reviewed by a Certified Arborist to make a final determination regarding which trees will need to be removed and which can be retained. At that time, a Tree Protection Plan should be developed by a certified arborist to protect retained trees from potential development impacts. The Tree Protection Plan should be in place and implemented prior to the commencement of any demolition, grading, staging or construction activities.
