Type of Services Phase I Environmental Site Assessment
and Preliminary Soil, Ground Water, and
Soil Vapor Quality Evaluation

Location 2550 Camino Tassajara
Danville, California

Client Trumark Homes LLC
Client Address 3001 Bishop Drive, Suite 100
San Ramon, California 94583

Project Number 206-51-1
Date October 5, 2017

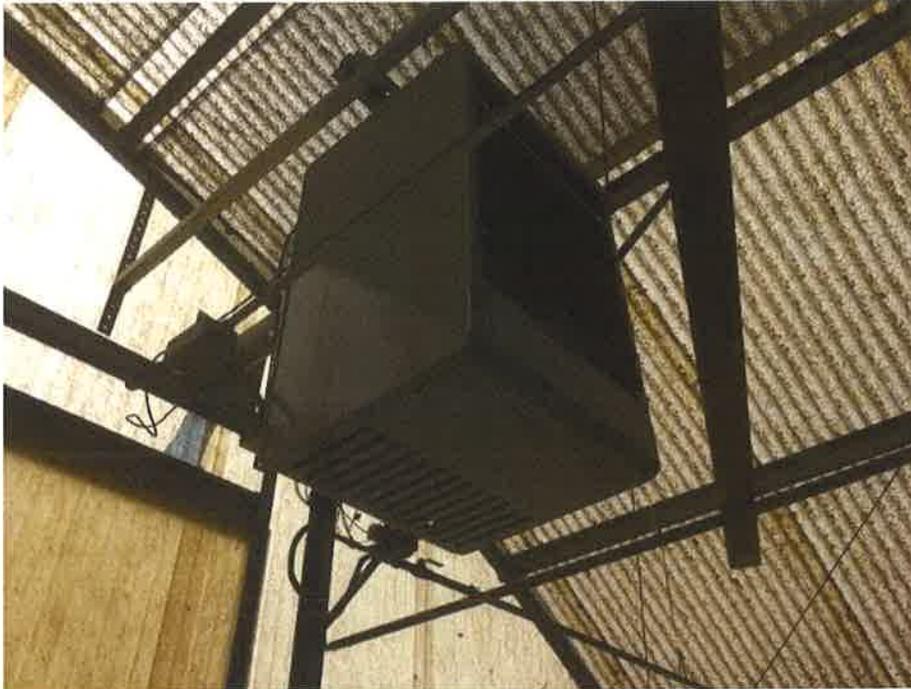
Photograph 9. Heater within greenhouse.

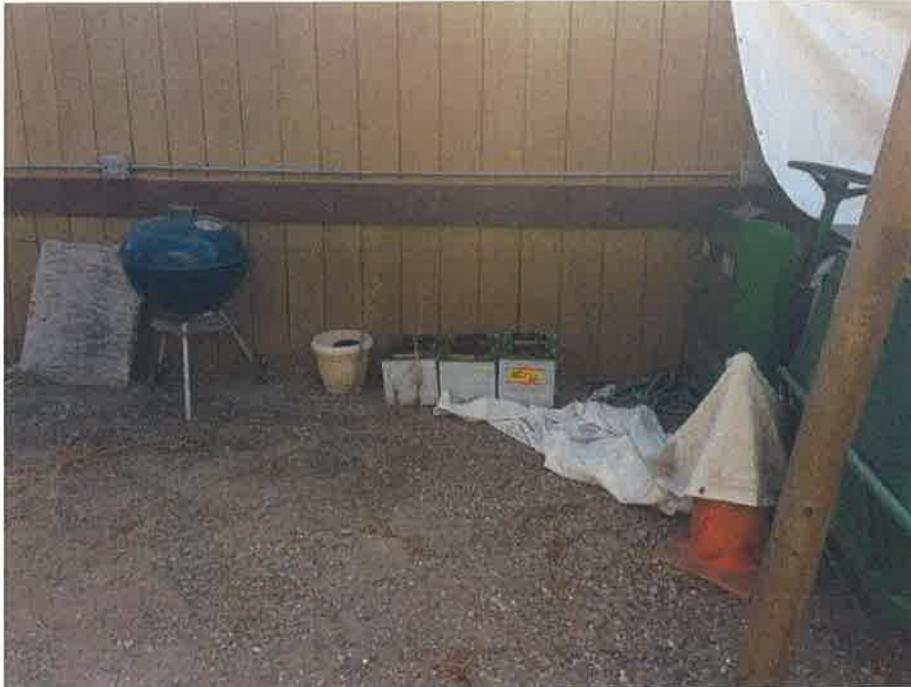
Photograph 11. Batteries for electric utility vehicles on-Site.

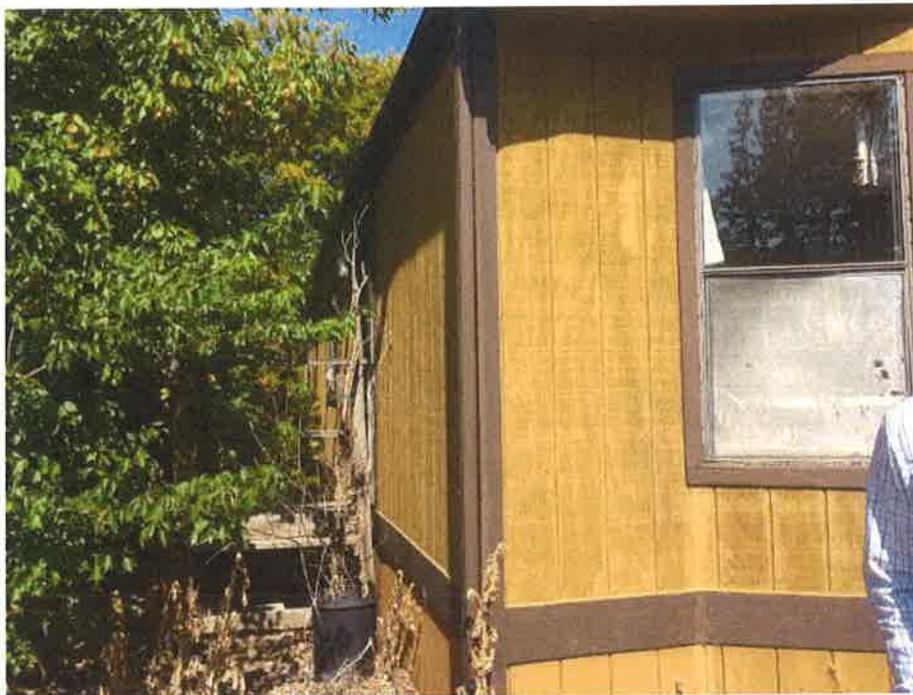
Photograph 13. Reportedly unoccupied mobile home in central portion of Site.

One septic system is reported to serve the Site. Although not observed, an additional septic system might be present in the vicinity of the mobile home. These septic systems should be properly abandoned in accordance with applicable regulations prior to site development.

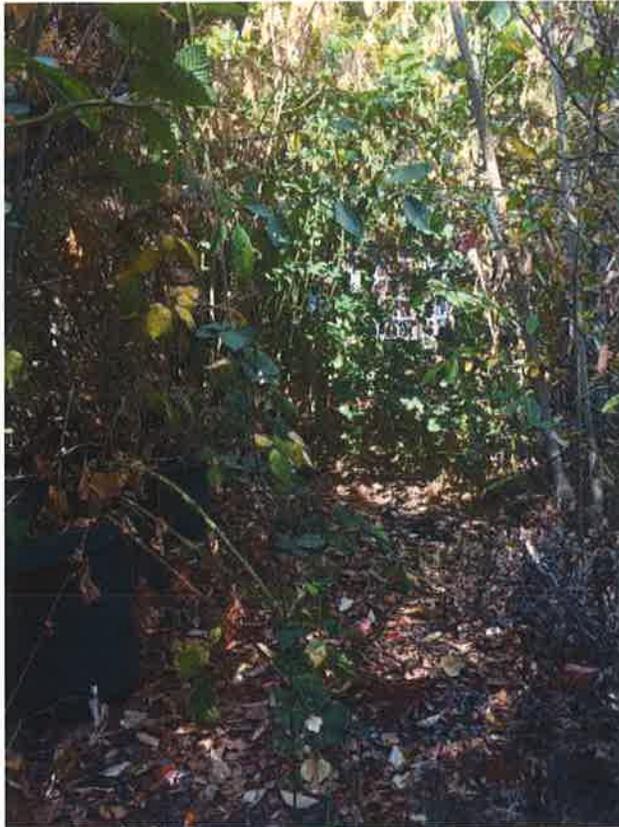
An approximately 1,000-gallon underground storage tank used for gasoline storage was identified by the representative of the nursery owner. The approximate location was pointed out during the Site visit as within overgrown bushes southeast of the fertilizer storage shed. Surface evidence (pipes, fill ports, vents, etc.) of this UST was not observed.

Photograph 19. Reported location of underground fuel tank.

One approximately 1,000-gallon gasoline UST is reportedly located on-Site. The reported approximate location was observed within overgrown shrubs during the Site visit, and no surface indications (fill port, monitoring system) were observed. Additionally, no permits for UST installation or removal were found during Cornerstone's search of records at San Ramon Valley Fire and Contra Costa County Environmental Health – Hazardous Materials.

- Presence of an approximately 1,000-gallon gasoline UST tank that is reportedly no longer used. Records pertaining to the installation or removal of this UST were not found by Contra Costa County Environmental Health – Hazardous Materials or San Ramon Valley Fire Department. Laboratory analyses of soil vapor and ground water samples indicate that this UST does not appear to have significantly impacted the subsurface. However, isolated areas of petroleum contamination may be encountered during removal that will require special consideration.

Although no significant impacts from the UST were detected during this investigation, pockets of impacted soil, soil vapor and ground water may be encountered in the vicinity of the UST during removal of the UST or construction activities, which may require special monitoring, handling and/or disposal. We recommend preparing a Site Management Plan (SMP) and Health and Safety Plan (HSP). The purpose of these documents will be to establish appropriate management practices for handling suspect conditions (e.g. soil with an odor or discoloration) or structures, if encountered during construction activities.

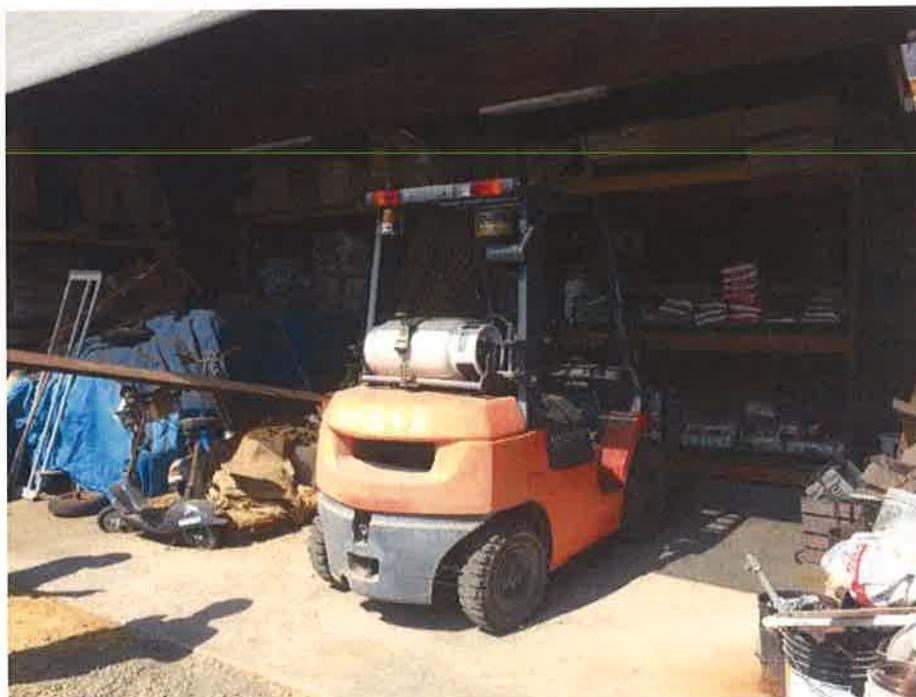
Photograph 20. Forklift and fertilizer, stored within large shed, south of retail building.

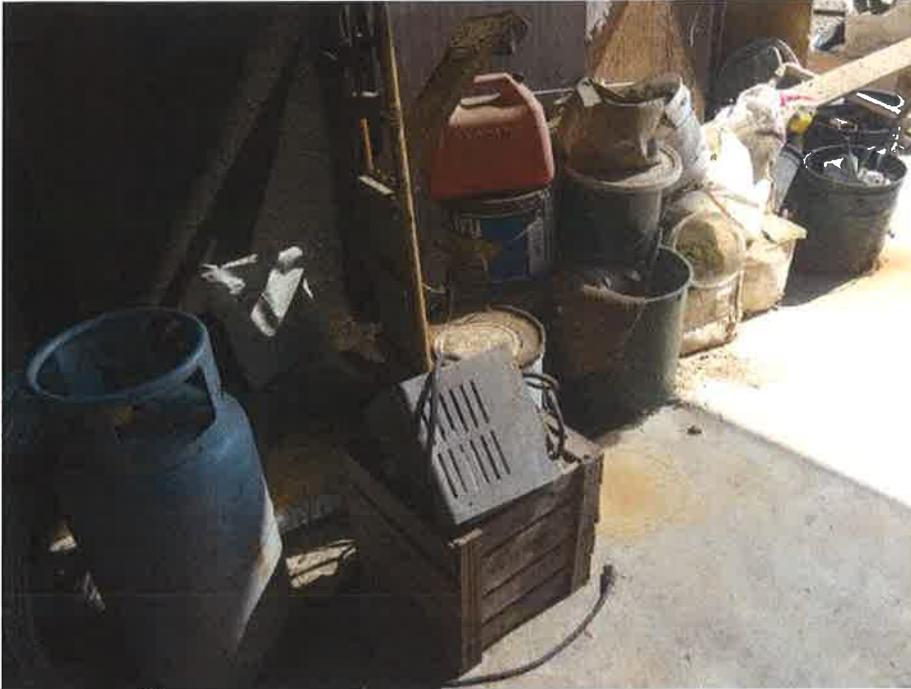
Photograph 21. Propane, gas can, asphalt sealant and additional maintenance-related materials within fertilizer storage area.

Chemical storage and use on-Site consisted on small quantities of hazardous materials (fertilizer, auto batteries, herbicide / pesticides for retail sale and presumed used on plants). The location of a reported underground fuel tank was identified during the Site visit, however, due to dense vegetation the exact location was unable to be observed. Permits or records of leaks for the UST not available at the San Ramon Valley fire department or Contra Costa County Environmental Health – Hazardous Materials.

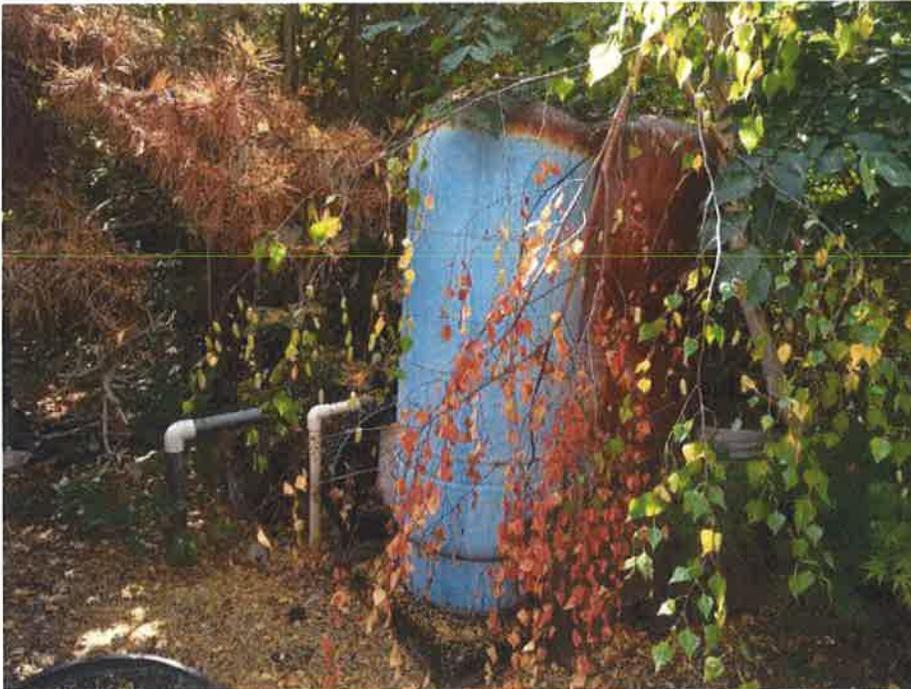
An irrigation water well and older wooden storage tank were also identified southeast of the fertilizer storage shed. A pressure tank was observed adjacent to the reported well location. According to the owner representative, the water well has not been used since approximately 1988 when the Site was connected to the municipal water system.

Photograph 22. Irrigation well and storage tank, located southeast of the fertilizer storage area.

An irrigation well is present on the Site and is reportedly no longer used. An associated 10,000-gallon above-ground wooden tank and smaller metal storage tank was observed near the well. This well should be properly abandoned prior to site development.

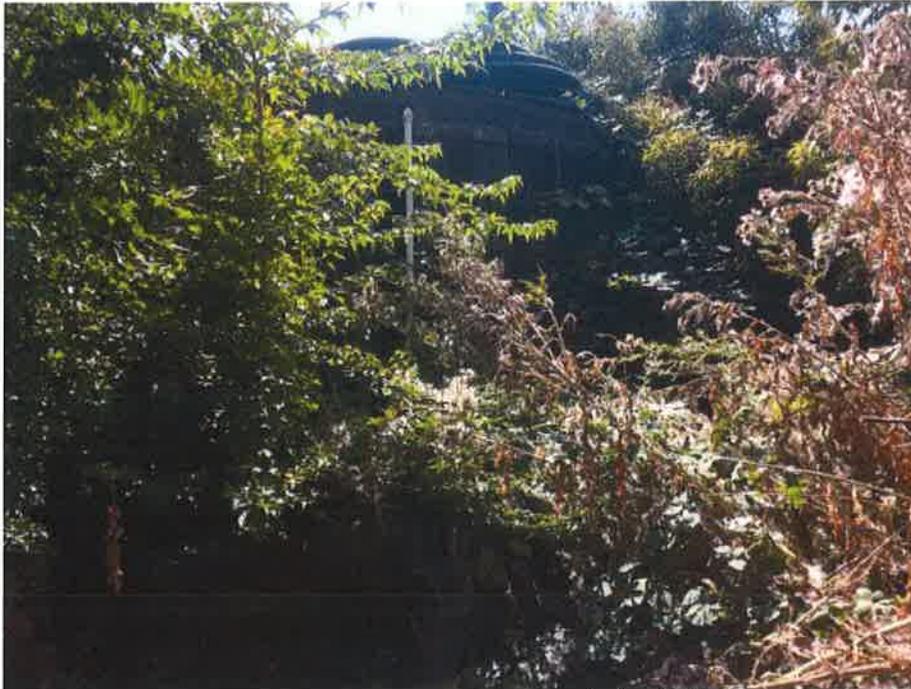
Photograph 23. Wooden elevated water storage tank, located southeast of the fertilizer storage area.
